7 Preservation Briefs

The Preservation of Historic Glazed Architectural Terra-Cotta

de Teel Patterson Tiller

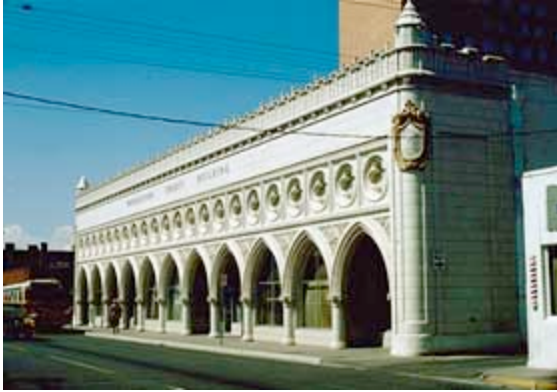
Glazed architectural terra-cotta was a practical and highly decorative building material. Photo: NPS files.

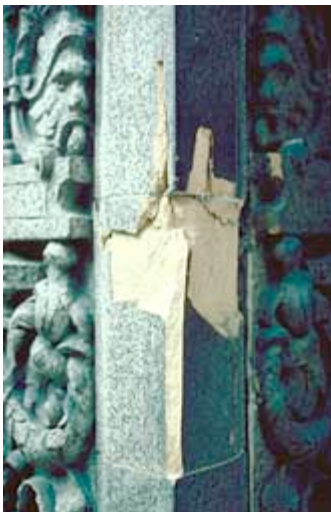
The damage shown here is the result of direct live load on a mid-rise building. The steel frame has settled and shifted the weight onto the exterior terra-cotta cladding, resulting in rupturing of the material. Photo: NPS files.

The development of large stress-related cracks or wholesale material deterioration is often caused by unaccommodated building-frame shortening under load, thermal expansion and contraction of the facade and moisture expansion of the glazed architectural terra-cotta units themselves. Cracks running through many units or stories or large areas of material deterioration often indicate stress-related problems. This sort of deterioration, in turn, permits significant water entry into the terra-cotta system.

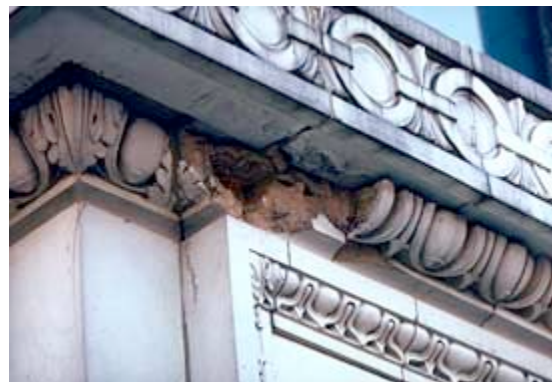
Material spalling is the result of excessive expansion of the porous tile body caused by water and freezing temperatures. This is a serious condition, often difficult to repair. Photo: NPS files.

Material spalling is a particularly severe situation. Not only is the visual integrity of the detailing impaired, but a large area of the porous underbody, webbing and metal anchoring is exposed to the destructive effects of further water entry and deterioration. Both glaze and material spalling must be dealt with as soon as possible. Missing units is a serious situation which particularly plagues architectural terra-cotta

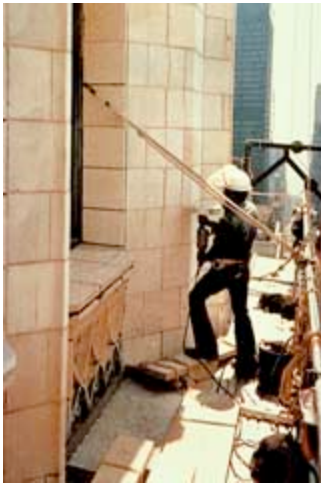
A worker cleans out mortar joints in preparation for repointing the architectural terra-cotta
Photo: NPS files.

Repointing: Repointing of mortar which is severely deteriorated or improperly or infrequently maintained is one of the most useful preservation activities that can be performed on historic glazed architectural terra-cotta buildings. Ongoing and cyclical repointing guarantees the long life of this material. Repointing should always be carried out with a mortar which has a compressive strength (measured in p.s.i.) *lower* than the adjacent masonry unit. Hard (Portland cement) or coarsely screened mortars may cause point loading and/or prevent the outward migration of the water through the mortar joints, both of which ultimately damage the terra-cotta unit. Repointing with waterproof caulking compounds or similar waterproof materials should never be undertaken because, like waterproof coatings, they impede the normal outward migration of moisture through the masonry joints. Moisture then may build sufficient pressure behind the waterproof caulk and the glaze on the terra-cotta to cause damage to the unit itself.

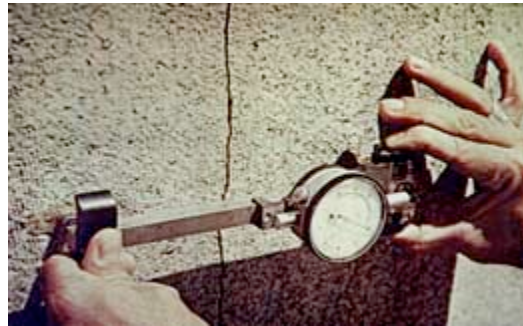
This crack is being measured. Structural cracking, whether static (nonmoving) or dynamic (moving) should be caulked to prevent water entry into the glazed architectural terra-cotta system. Photo: NPS files.

damage: Holes, sign anchors, slots for channel steel, or structural cracking in the surface of glazed architectural terra-cotta cladding should be permanently sealed with a material that will expand with the normal dynamics of the surrounding material, yet effectively keep water out of the system. Any one of a number of commercially available waterproof caulking compounds would be appropriate for this work. Holes and static (non-moving) cracks may be caulked with butyl sealants or acrylic latex caulks. For dynamic (moving or active) cracks, the polysulfide caulks are most often used, although others may be safely employed. It is, however, important to remember that these waterproof caulking compounds are not viable repointing materials and should not be used as such.
