16 Preservation Briefs

Technical Preservation Services
National Park Service
U.S. Department of the Interior

The Use of Substitute Materials on Historic Building Exteriors

Sharon C. Park, AIA

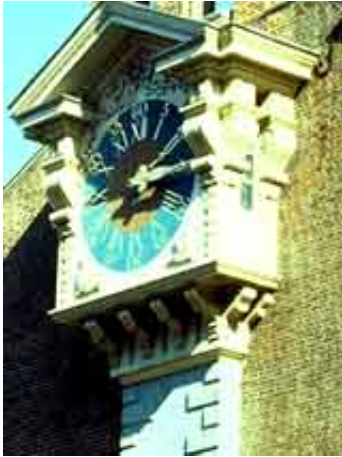
In the reconstruction of the clock tower at Independence Hall, the substitute materials used were cast stone and wood with fiberglass and polyester bronze ornamentation. Photo: NPS files.

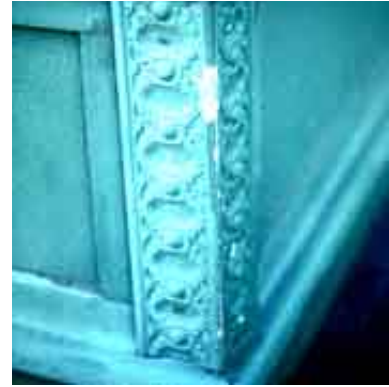
Substitute materials need to be located with care to avoid damage. The fiberglass column base has chipped, whereas the historic cast iron would have remained sound. Photo: NPS files.

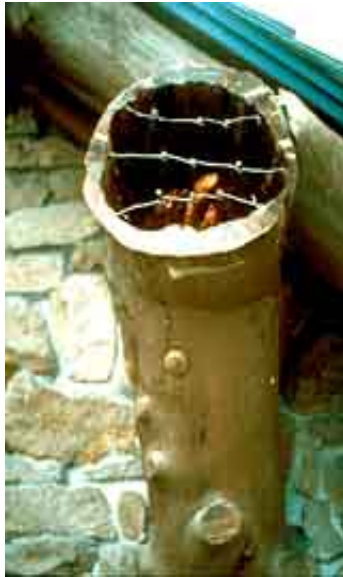
The core of a deteriorated wood outrigger was first drilled out. Photos (left and right): Courtesy, Harrison Goodall.

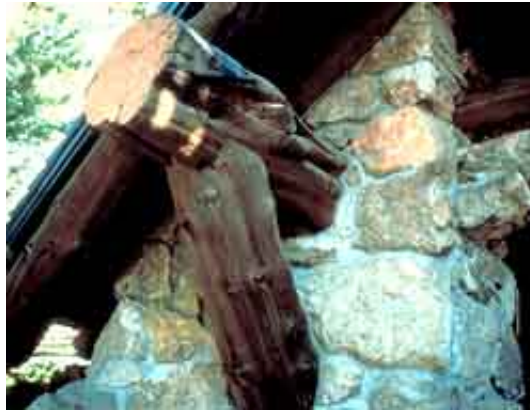
An inert material was injected into the hollow outrigger, permitting the outer wood to be retained and preserved.

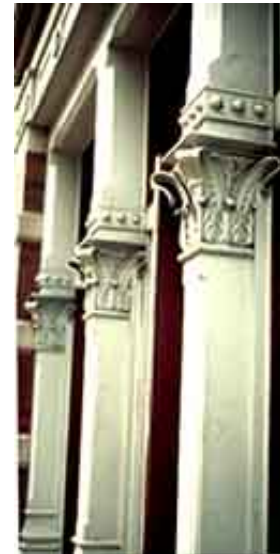
Cast aluminum has been used as a replacement material for cast iron. Photo: NPS files.

Application: Cast aluminum can be a substitute for cast iron or other decorative elements. This would include grillwork, roof crestings, cornices, ornamental spandrels, storefront elements, columns, capitals, and column bases and plinth blocks. If not self-supporting, elements are generally screwed or bolted to a structural frame. As a result of galvanic corrosion problems with dissimilar metals, joint details are very important.

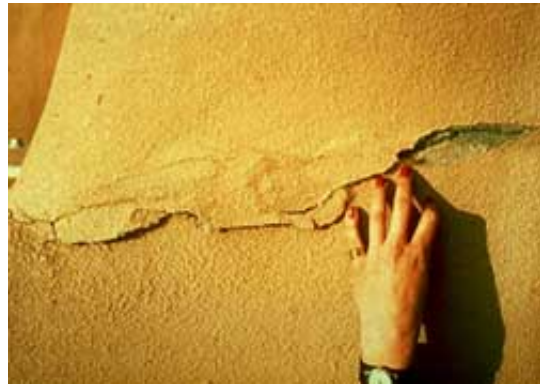
A waterproof coating is an inappropriate substitute material to apply to adobe as it seals in moisture and may result in spalling. Photo: NPS files.

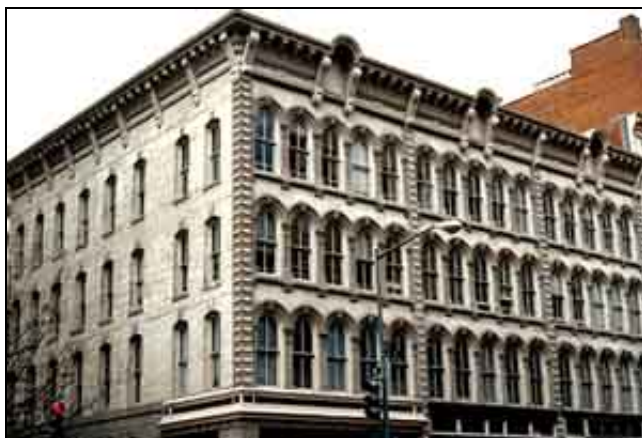
The historic cornice was successfully replaced with a fiberglass cornice. Photo: NPS files.
